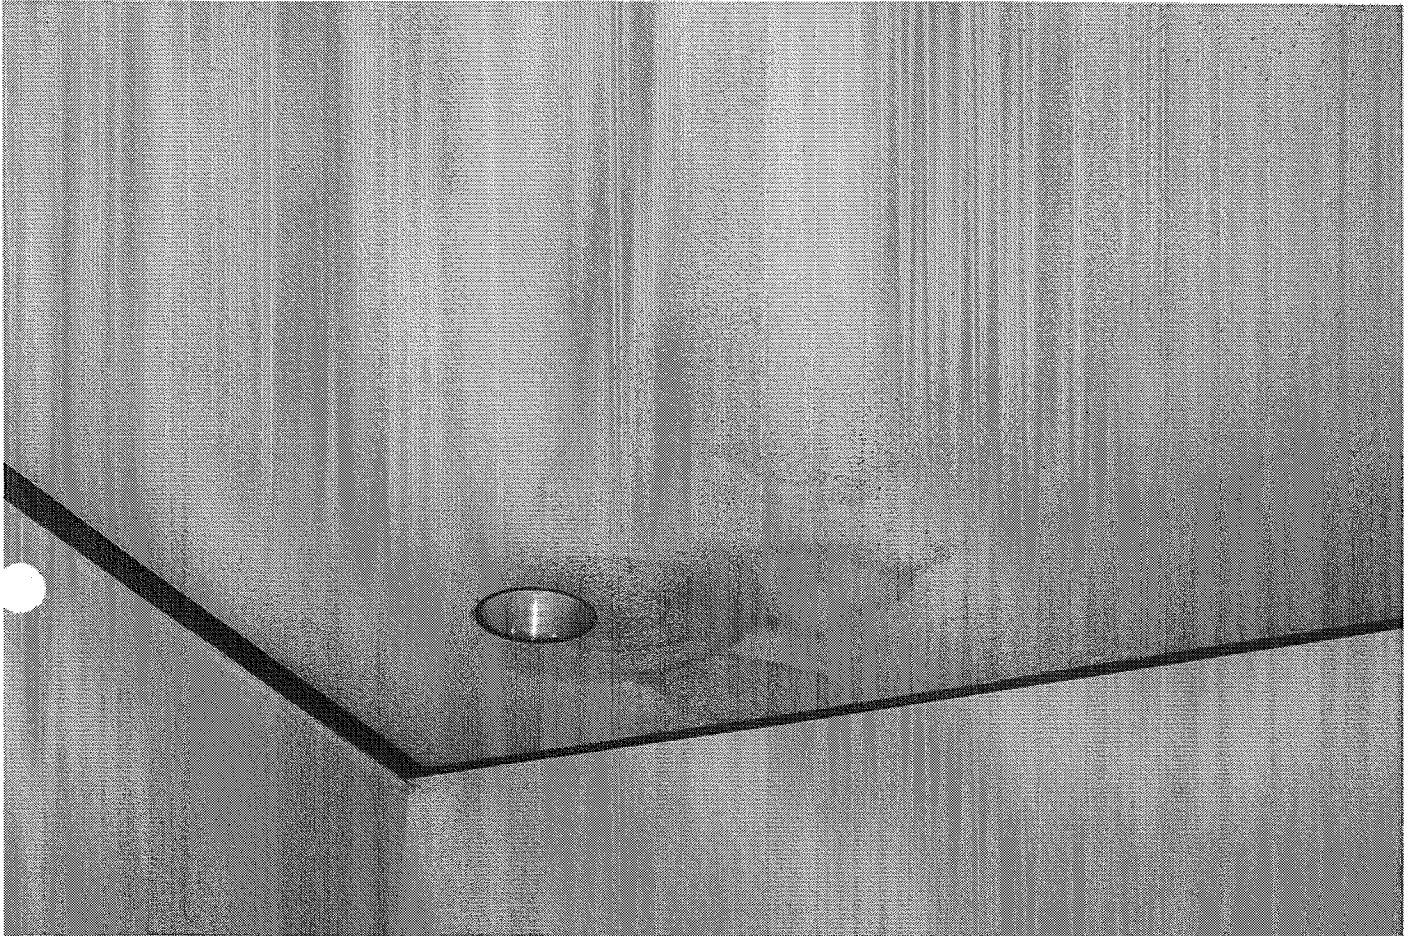
68. 1st floor west office areas - General view of water damaged acoustical plaster next to light

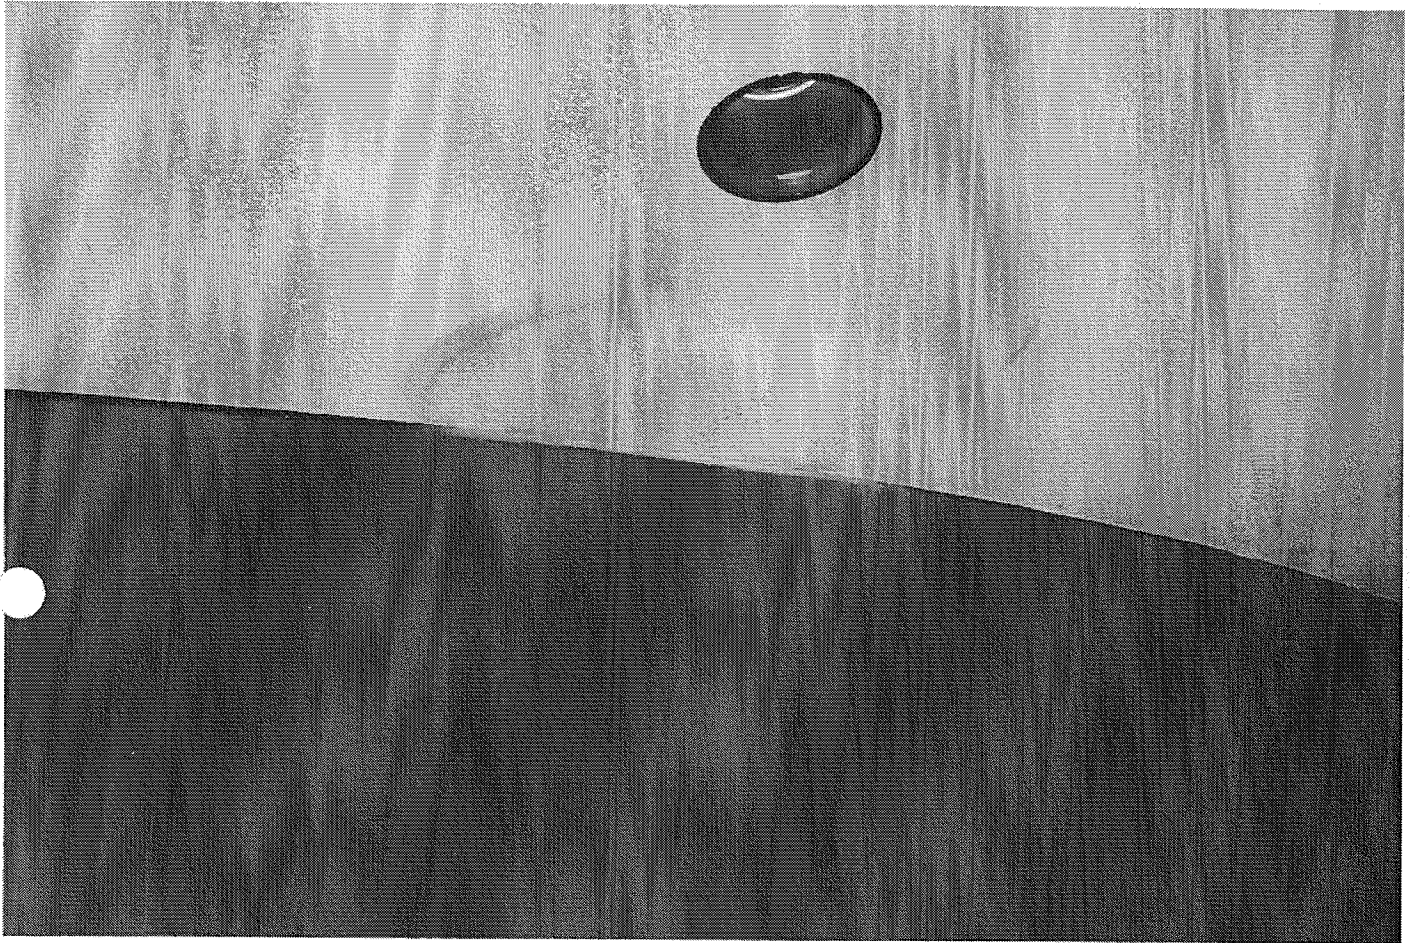
69. 1st floor north office areas - General view of water damaged acoustical plaster next to light

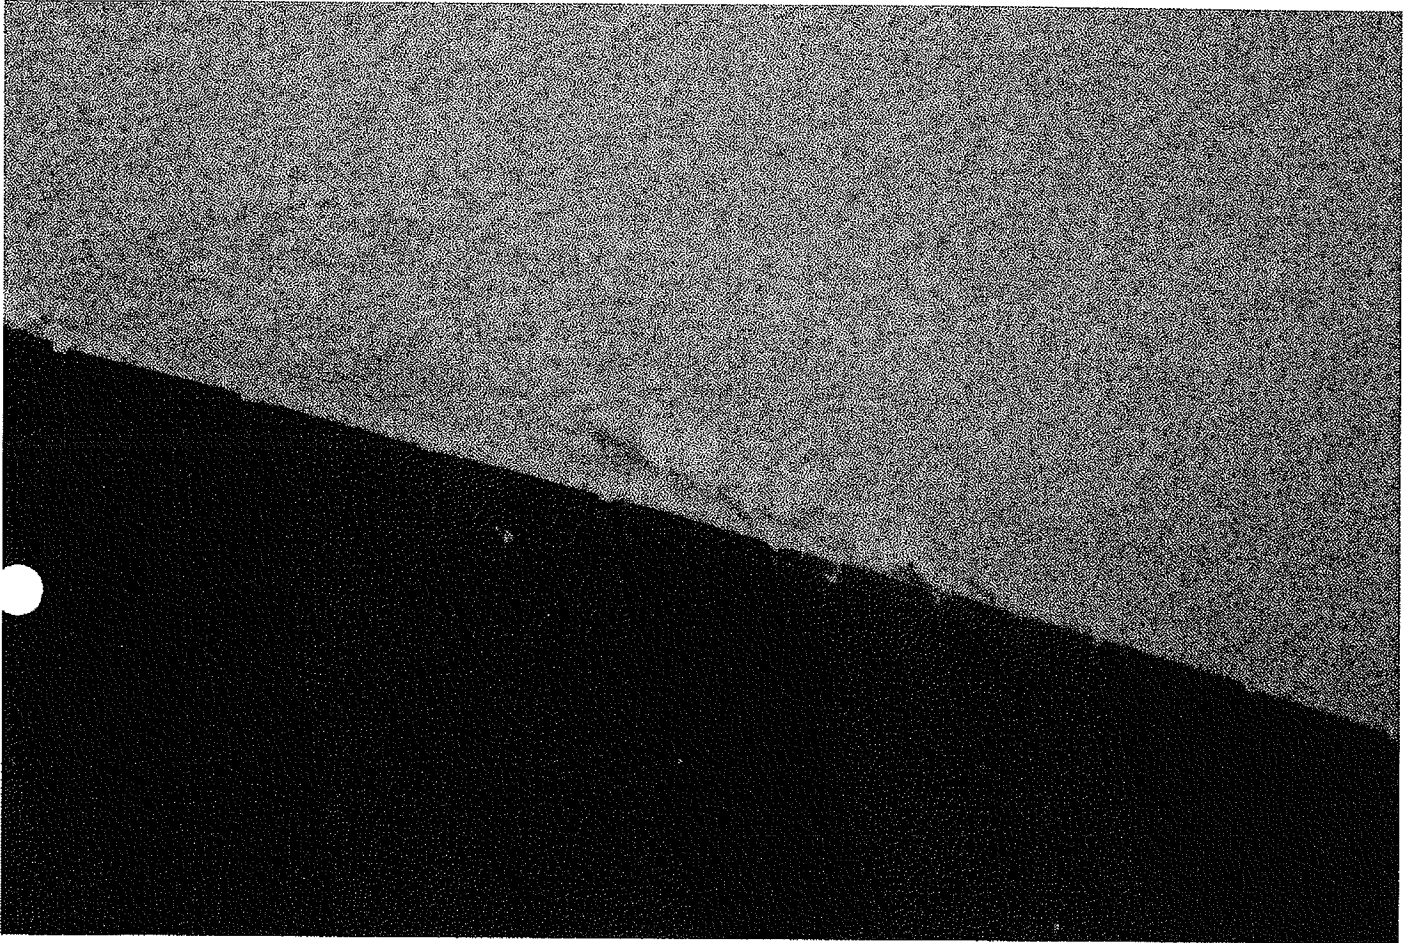
70. 1st floor north office areas - Damaged acoustical plaster on outside of auditorium wall

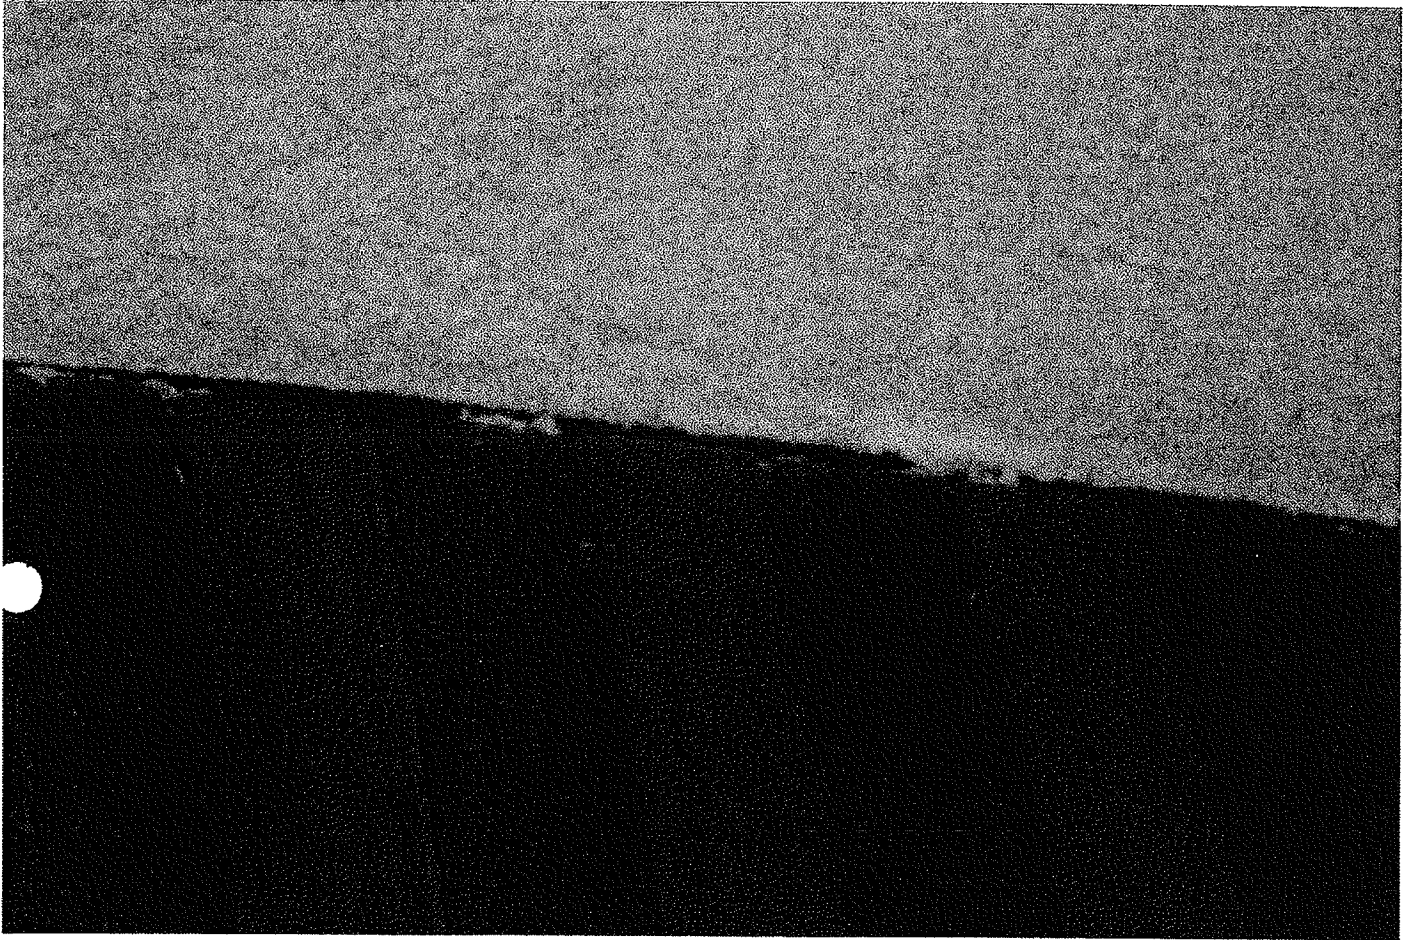
71. 1st floor auditorium - Close-up of impact damaged acoustical plaster in hallway outside auditorium

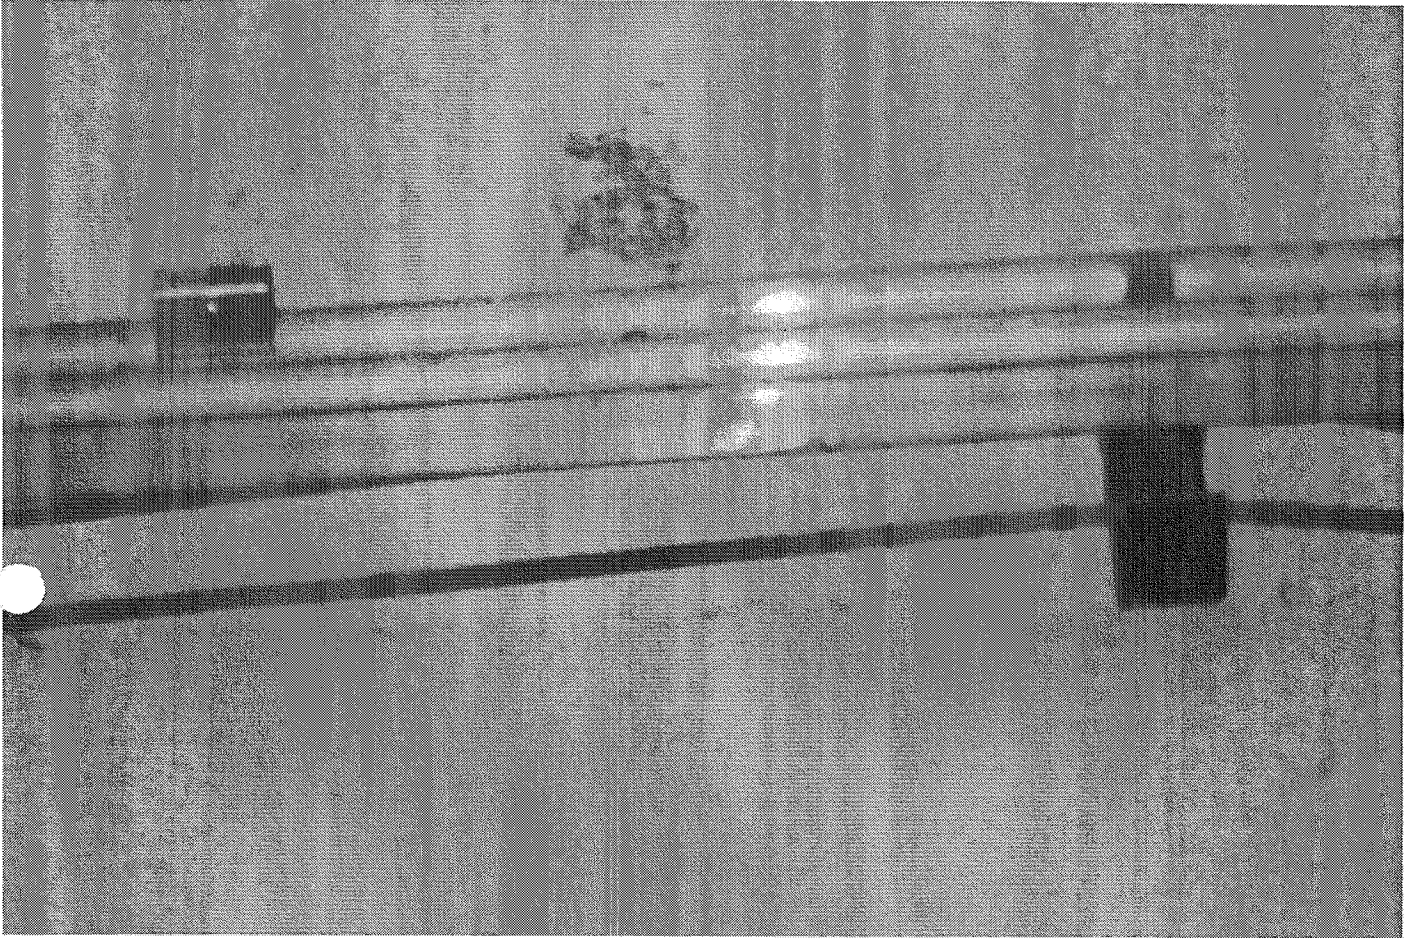
73. 1st floor auditorium - Damaged acoustical plaster on inside of auditorium wall
